Errata

Oct, 2019

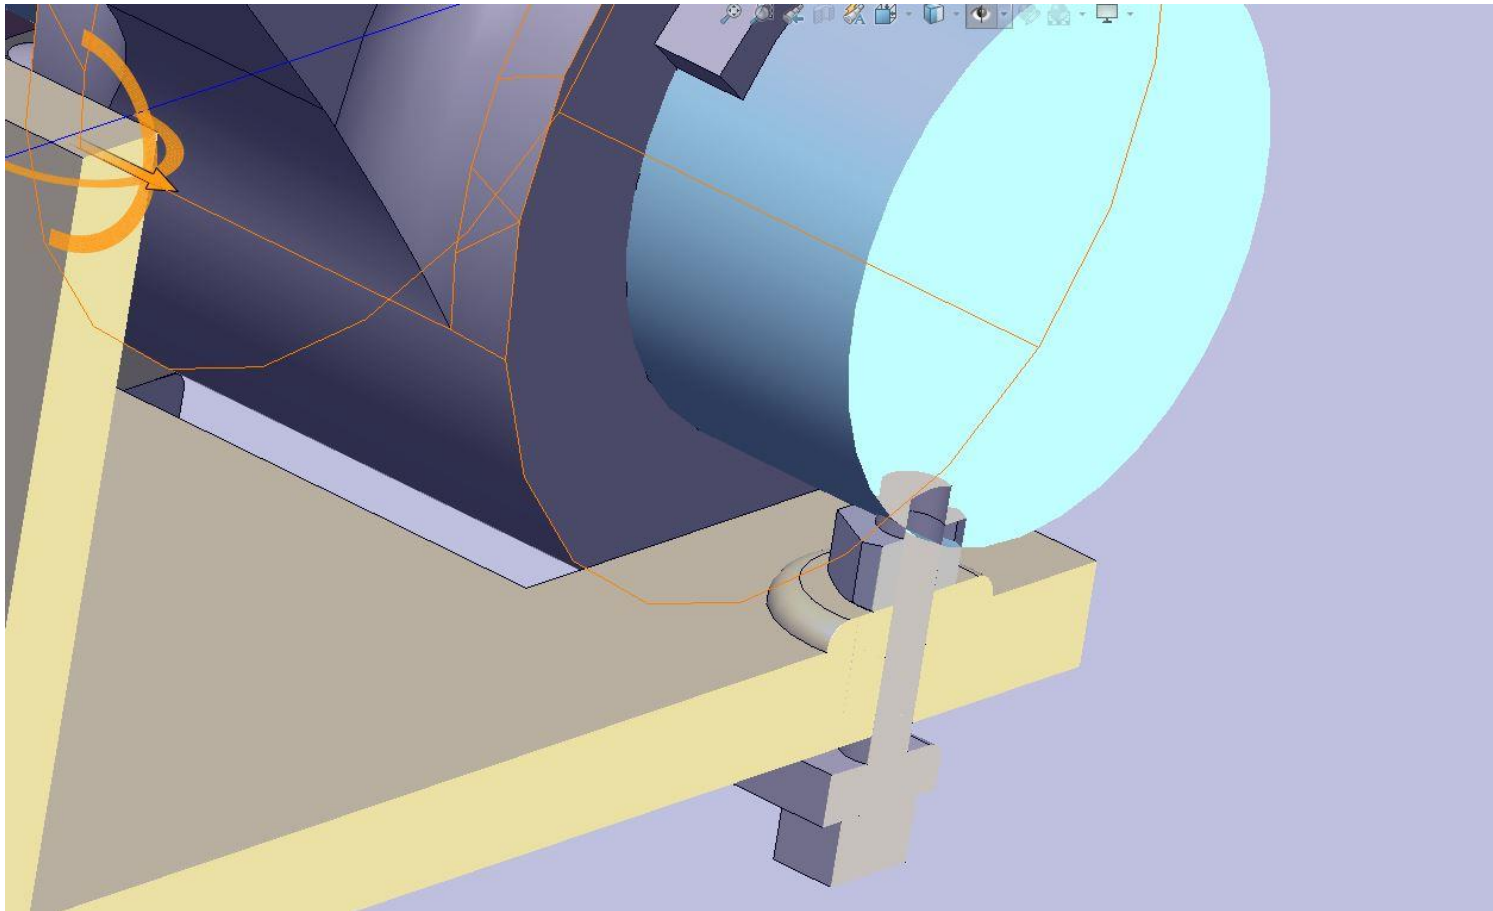
It appears that interference would occur between the Rock Shafts and some of the Bedplate mounting screws/nuts.

Here is a pictorial view of the problem. Rich Carlstedt

I assume they removed material from the Rock Shafts when fitting them in order to have clearance between the screws and the shaft.
